Strategies to Improve and Preserve Flexible Pavement at Intersections

Research Report 0-5566-1

Conducted for
Texas Department of Transportation
P.O. Box 5080
Austin, Texas 78763

January 2011

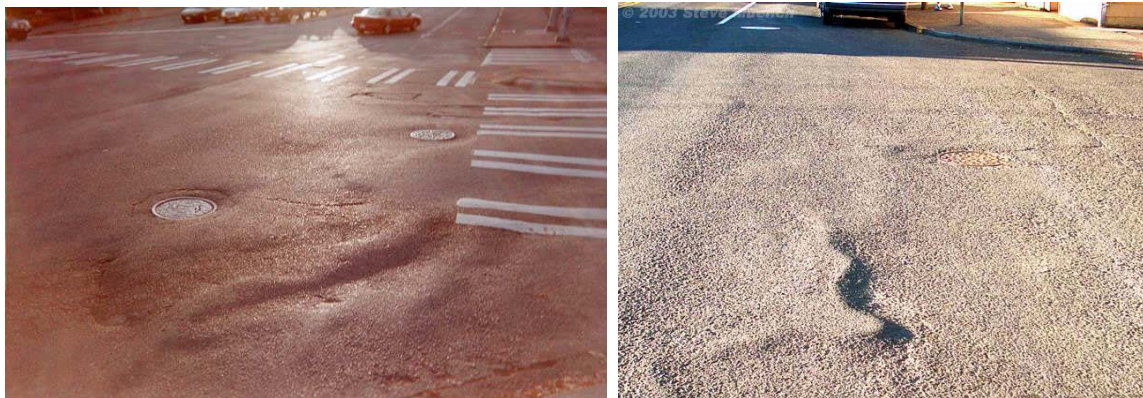
Shoving of an asphalt concrete pavement is defined as the longitudinal surface displacement of the HMA. Shoving is usually caused by an unstable asphalt layer that is not strong enough to resist horizontal stresses. Acceleration and deceleration of vehicles represent a continuous load in the same direction that generally causes shoving as shown in Figure 2.6. Excess binder in the mix, mistakes on the gradation, and erroneous temperature during compaction are parameters that cause a weak asphalt mixture. These potential problems along with poor bonding between the HMA and the underlying layer decrease the resistance to horizontal stresses leading to shoving. Shoving can be easily identified by distortion of pavement markings, and vertical displacements (dips and bumps). In many cases shoving is manifested with a large “bow wave” in front of the braking section or areas where HMA abuts a rigid object such as utilities. Shoving affects ride quality and may represent a safety hazard.

Figure 2.6 - Shoving on Asphalt Pavements.

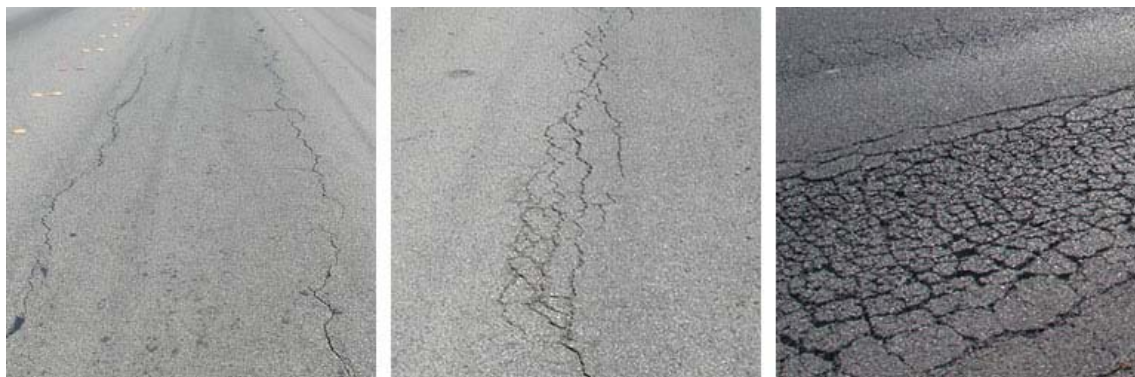
Fatigue in asphalt pavement manifests itself in the form of cracking from repeated traffic loading (Suo et. al., 2007). Three main factors that affect the initiation and propagation of fatigue cracking are the mix design, pavement structure, and construction procedures. The main visual characteristics of fatigue cracking are the interconnection of cracks in a chicken wire/alligator pattern as seen on Figure 2.7.

Figure 2.7 - Fatigue or Alligator Cracking on Asphalt Pavements.

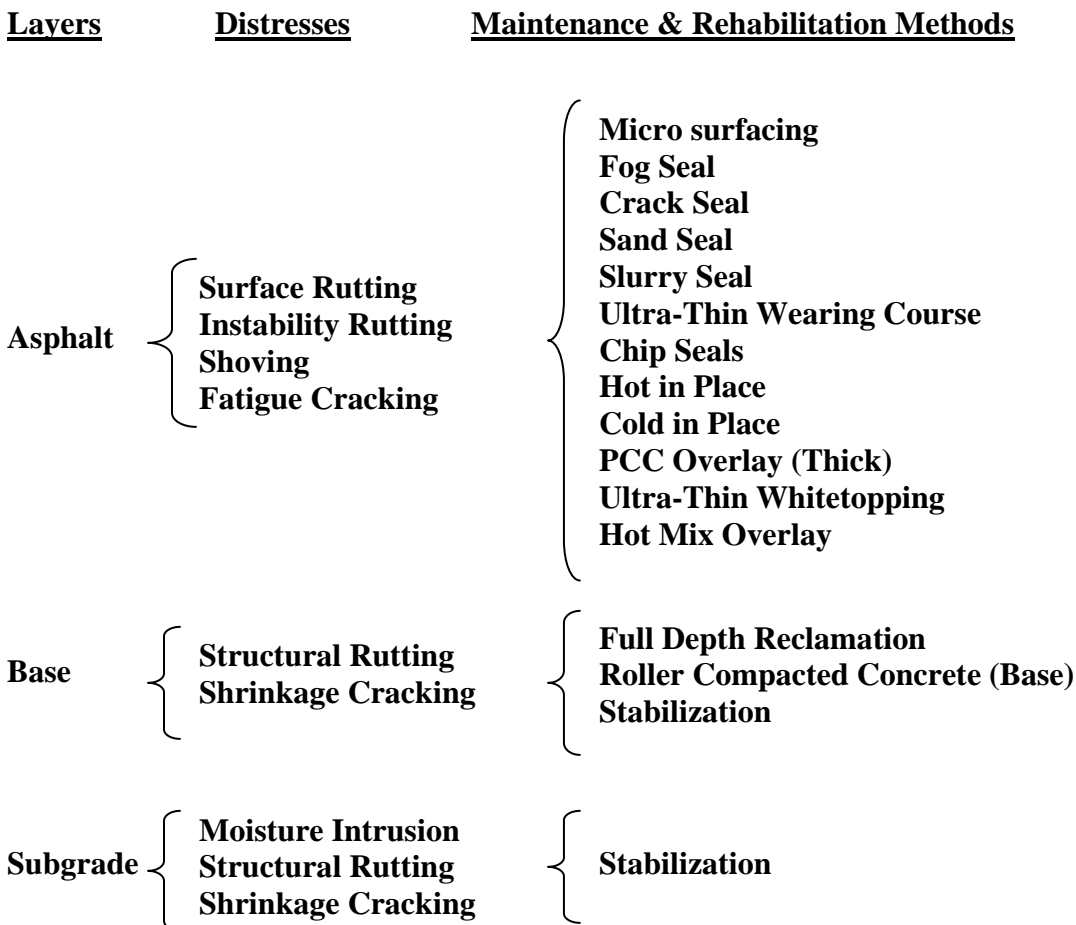
Figure 2.11 - Probable Appropriate Remediation for Different Layers

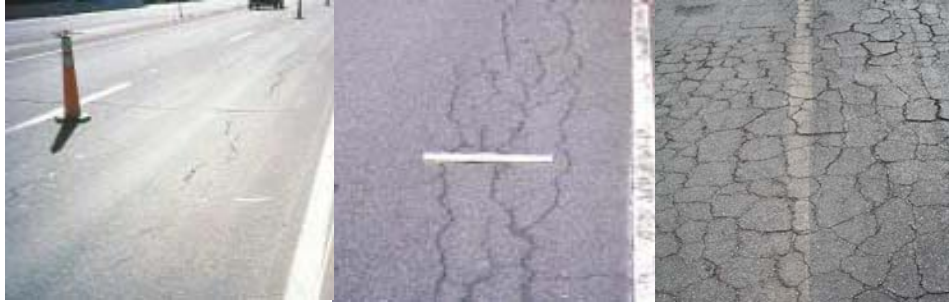
* - Figure 4.3 present the photos used to identify the severity level at intersections for alligator cracking.

Low Severity: Few connecting cracks with no spalling; cracks are not sealed.

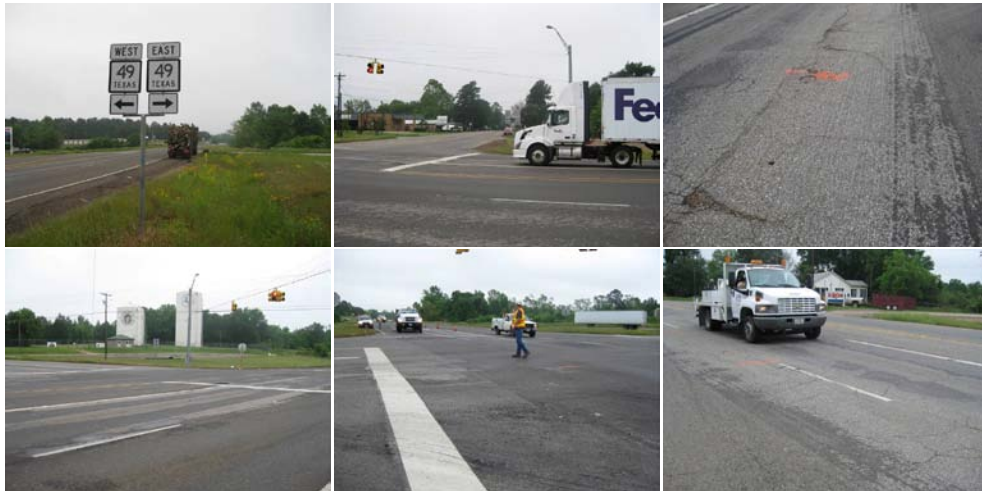
Figure 5.4 - Views of the Conditions of SH 155 and SH 49 Intersection.

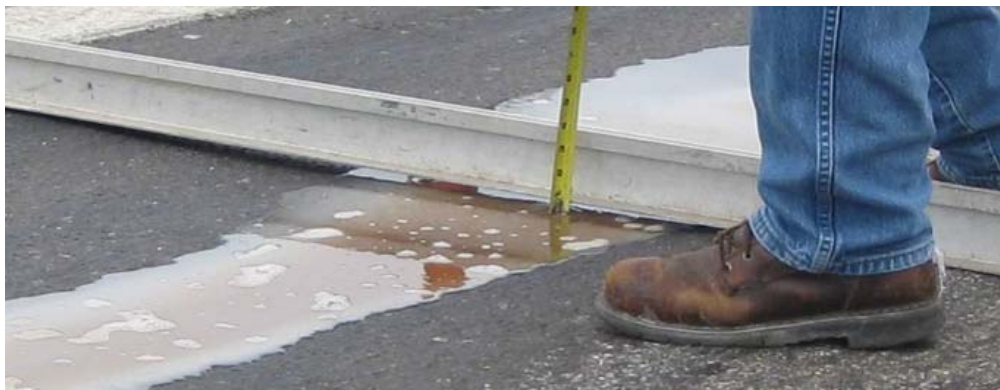
As shown in Figure 5.5, the maximum rut depth was 0.5 in. on SH155. This distress can be classified as Moderate Severity Structural Rutting. Another distress observed was fatigue cracking with low to high levels of severity, increasing in severity as one approached the intersection. Other distresses included transversal and block cracking specially after crossing the intersection.

Figure 5.5 - Rut Depth Measurement on SH 155.

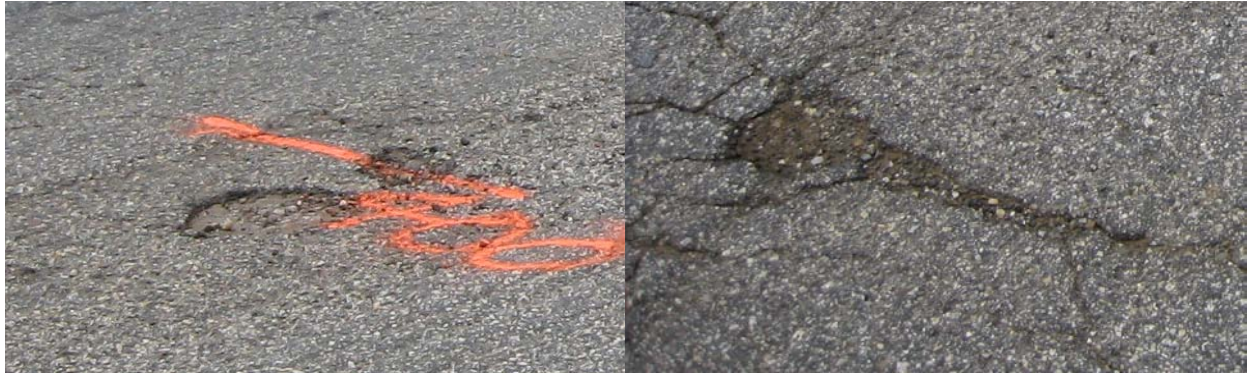
The first 300 ft of SH 49 consisted of a different asphalt mix than the mix closer to the intersection. On the west side, close to the intersection on the eastbound SH 49, a section of approximately 42 yards in length had been milled so no rut profile could be taken in that area. Based on the cores, several lifts were added over time to this intersection. Cores were not extracted from the milled section. It is suspected that the section was heavily rutted and the maintenance crew had overlaid that portion. In addition, transverse cracking could be seen all the way along the 500 ft approach while severe block cracking was seen at the intersection. In some areas, the severe block cracking contributed to generation of secondary distresses as depicted in Figure 5.6.

Figure 5.6 - Cracking Resulting in Potholes on SH 49.

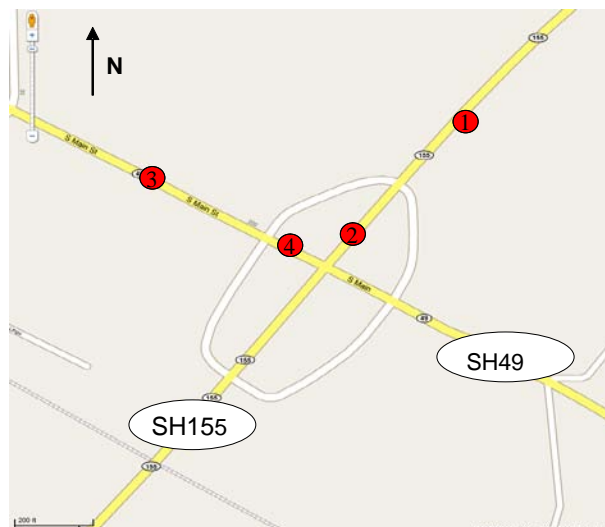
Figure 5.7 - Location of the Core Extractions.

For coring purposes, four strategic locations were selected, 2 locations per road, with one location 500 ft away from the intersection, and the other location within 100 ft of the intersection, all in the approaching lanes. Three cores were extracted from each location, one on each wheel-path and one between the wheel-paths, making it a total of 12 core extractions as marked in Figure 5.7.

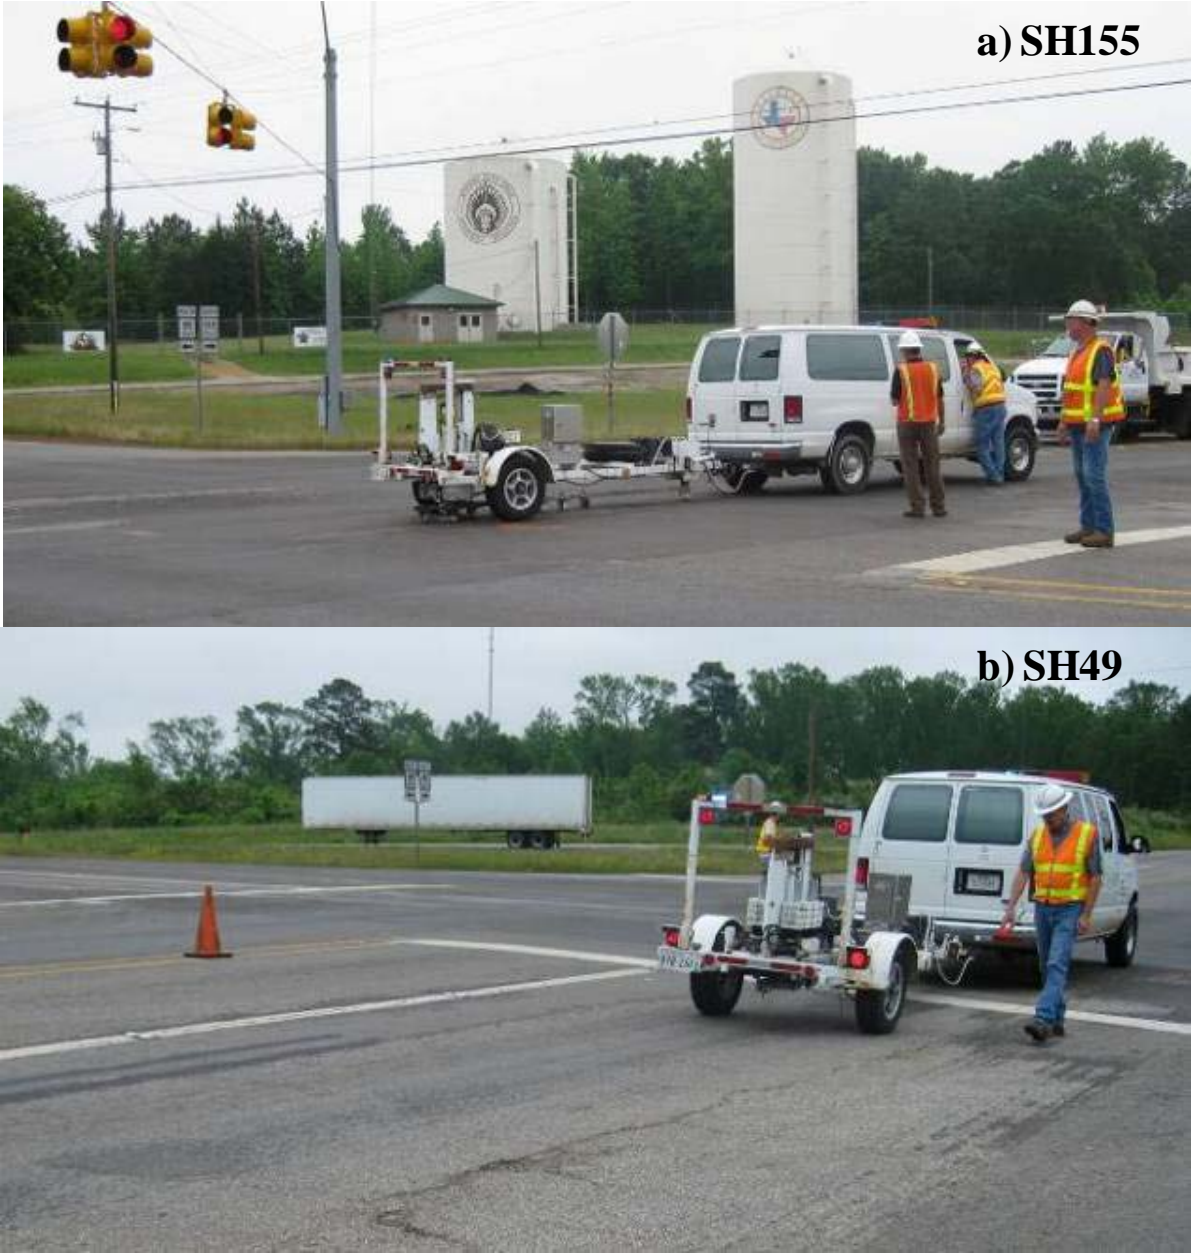
Deflection data were collected using a Falling Weight Deflectometer (FWD). FWD data along SH 155 were collected from 500 ft north of the intersection to 500 ft past the intersection. Data was collected at 25 ft intervals except in the vicinity of the intersection where data was collected more densely (see Figure 5.8a). The same was performed for SH 49, starting 500 ft west of the intersection (see Figure 5.8b). An air-launched Ground Penetrating Radar (GPR) was also used along these two roads.

Figure 5.8 - FWD Collection on SH 155 and SH 49 Images.

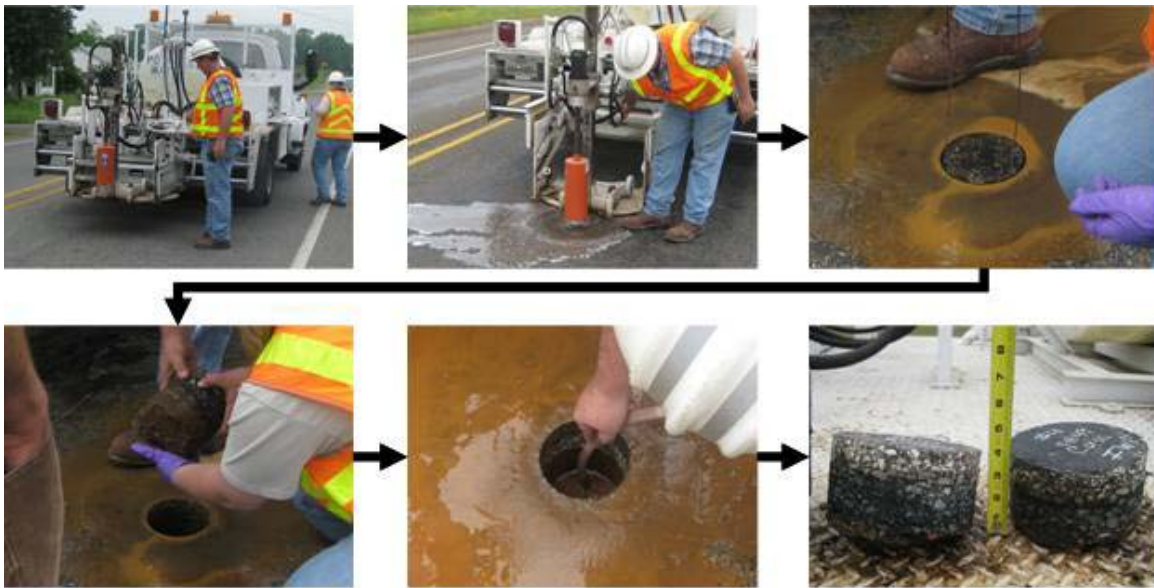
Figure 5.9 shows the coring process and a sample of the cores that were extracted. Cores were extracted from 4 locations as mentioned before, locations 1 and 2 were on SH 155, while locations 3 and 4 on SH 49. Dimensions and weight of every core were measured, and the V-meter test was performed on each sample to calculate the modulus of the asphalt layer from different locations. The asphalt content of each core was determined using an ignition oven. Sieve analysis was carried out on the retrieved aggregates from the oven to determine the gradation. Summaries of the analyses, results and images of each core extracted are included in Appendix G.

Figure 5.9 - Coring Process Images.

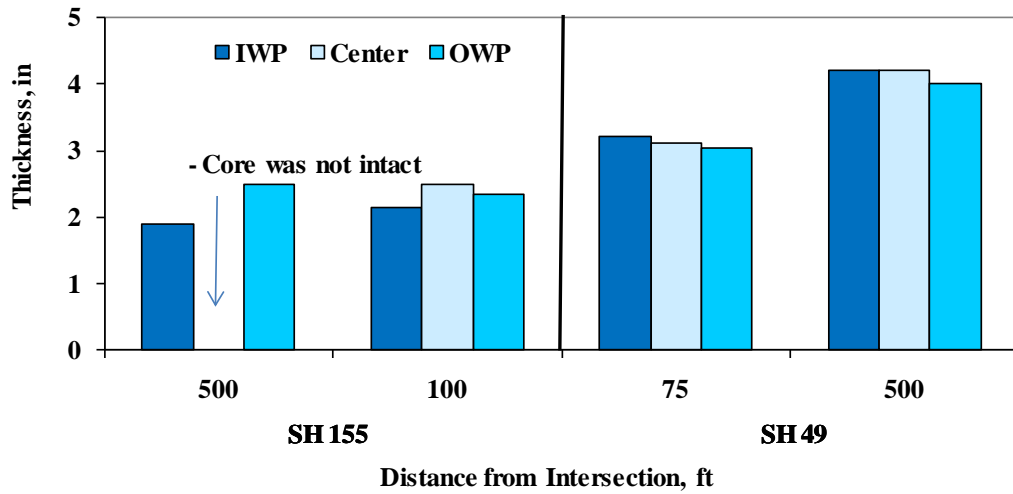
Figure 5.10 - Core Average Thicknesses as Approaching the Intersection.

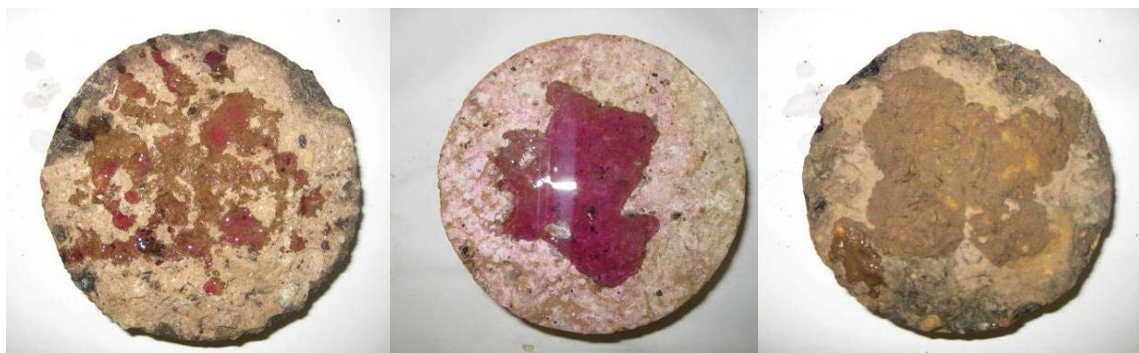
a) Set 2 on SH 155

b) Set 3 on SH 49

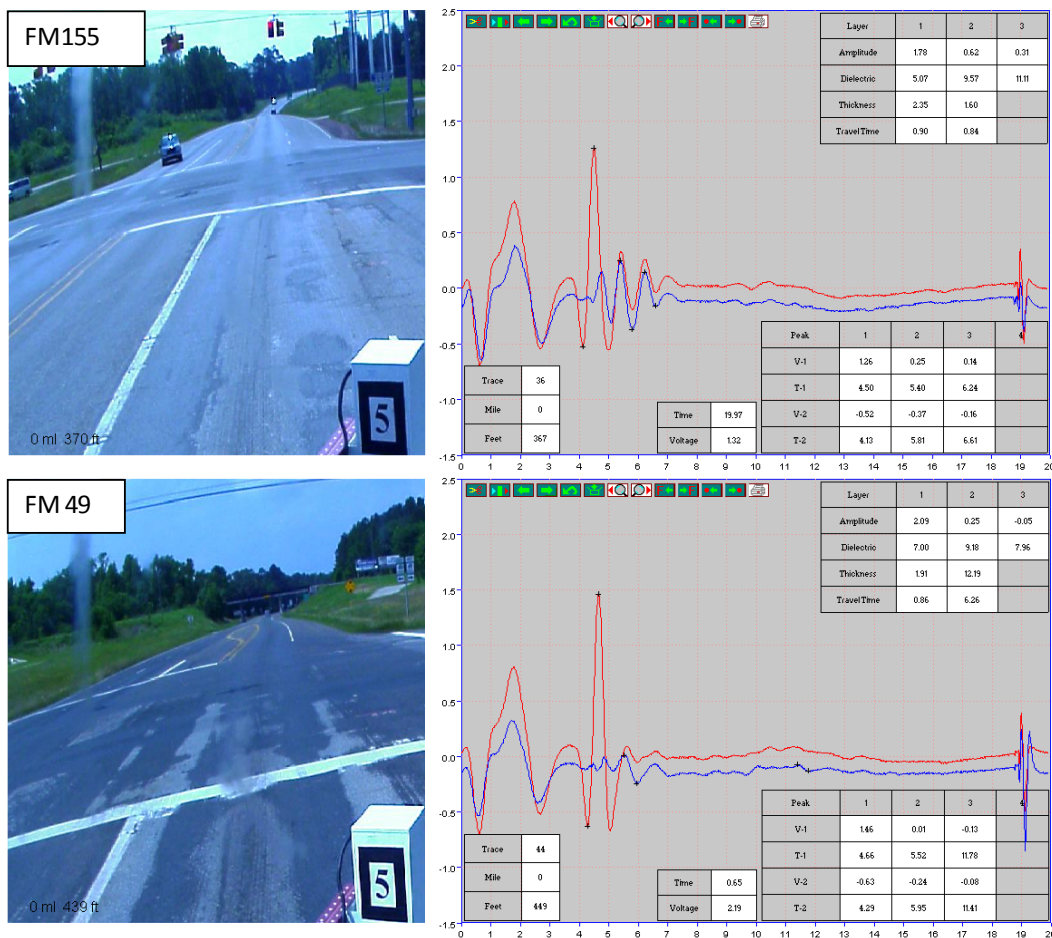
Figure 5.15 - Sample of the GPR Data Close to the Intersection of FM155 and FM49.

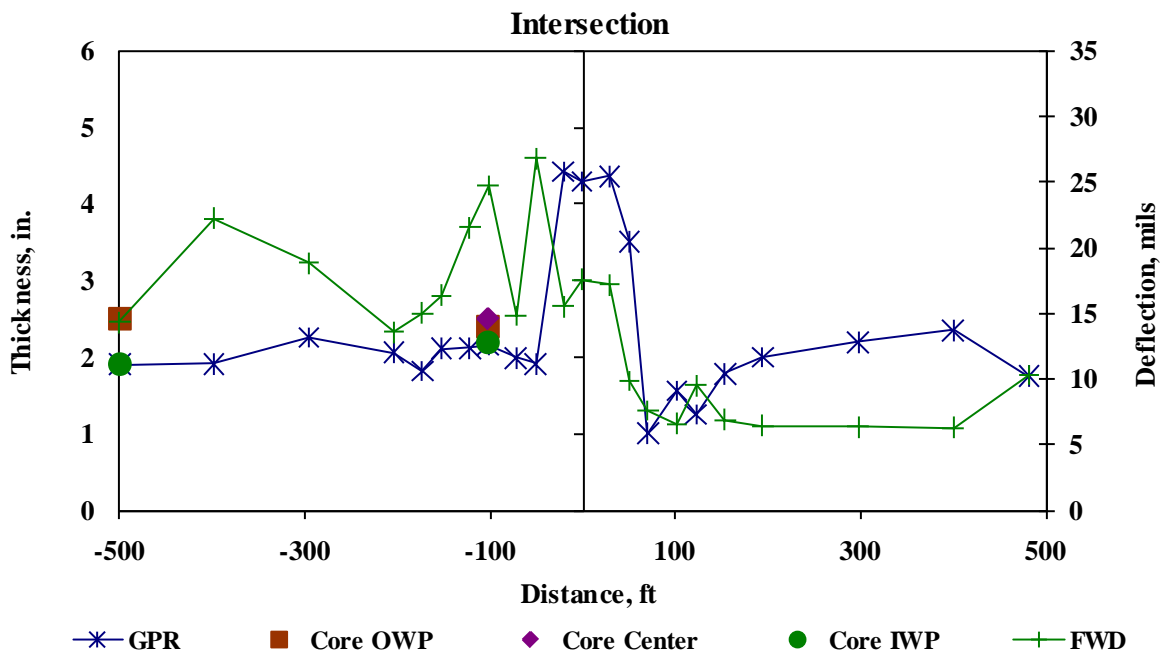
Figure 5.16 - GPR, FWD and Cores on SH 155.

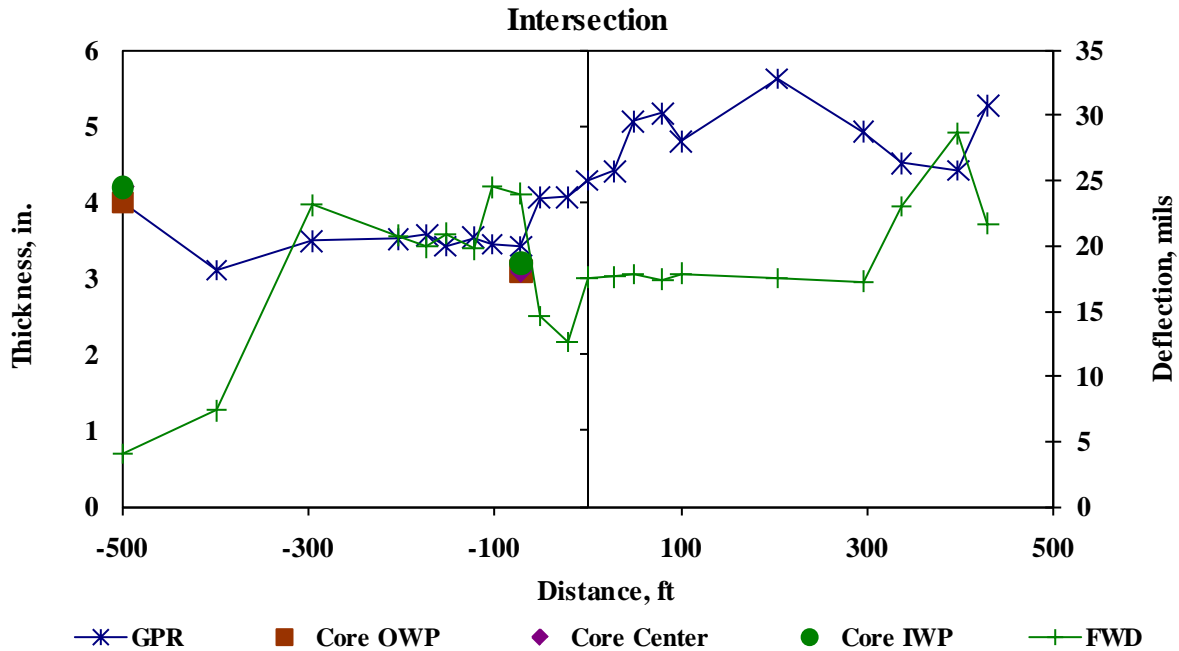
Figure 5.17 - GPR, FWD and Cores on SH 49.

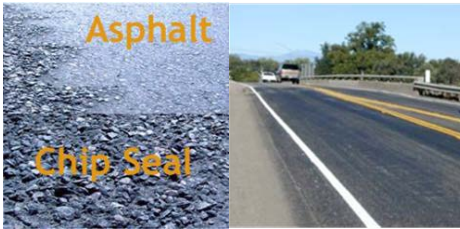
PRODUCT DESCRIPTION: A chip seal is a single thin surface treatment constructed by spraying a bituminous binding agent and immediately spreading and rolling a thin aggregate cover. The bituminous binding agent can be emulsified asphalt, cutback asphalt, or asphalt cement. The aggregate used is a single-sized crushed aggregate chip; the maximum chip size is most commonly 1/4 to 3/8 in., although larger chips have been used successfully on roads with heavy truck traffic. The thickness of the constructed chip seal layer is equal to the maximum size of the aggregate chips

used. Typical use of chip seal is for road surfacing such as preventative maintenance treatment for small cracks, bleeding, raveling, and loss of surface friction. Chip seals are a widely used alternative for surfacing low volume roads. They protect underlying materials from water and erosion and provide a relatively smooth riding surface. In general, chip seals provide an economical and relatively durable surface that is safe under normal weather and driving conditions. Chip seals can also be placed over new

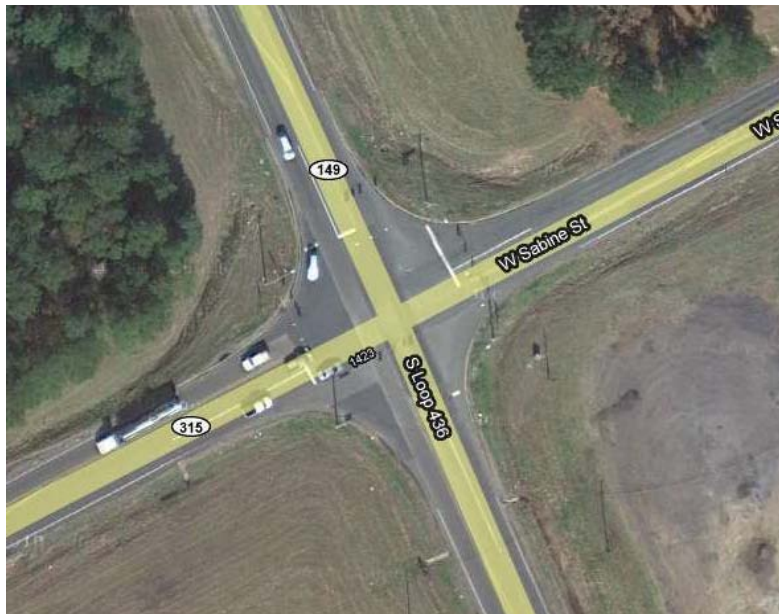
Figure 7.1 - Aerial View of SH315 and SH149 Intersection.

Figure 7.1 depicts the aerial view of the intersection. An inspection at the intersection was performed in April 2009. This is a typical rural intersection with a light signalization consisting of flexible pavement only. The investigation concentrated on the intersection portion of the roadway. With the assistance from the District personnel, 500 ft sections of the road on either side of the intersections were closed off to traffic.

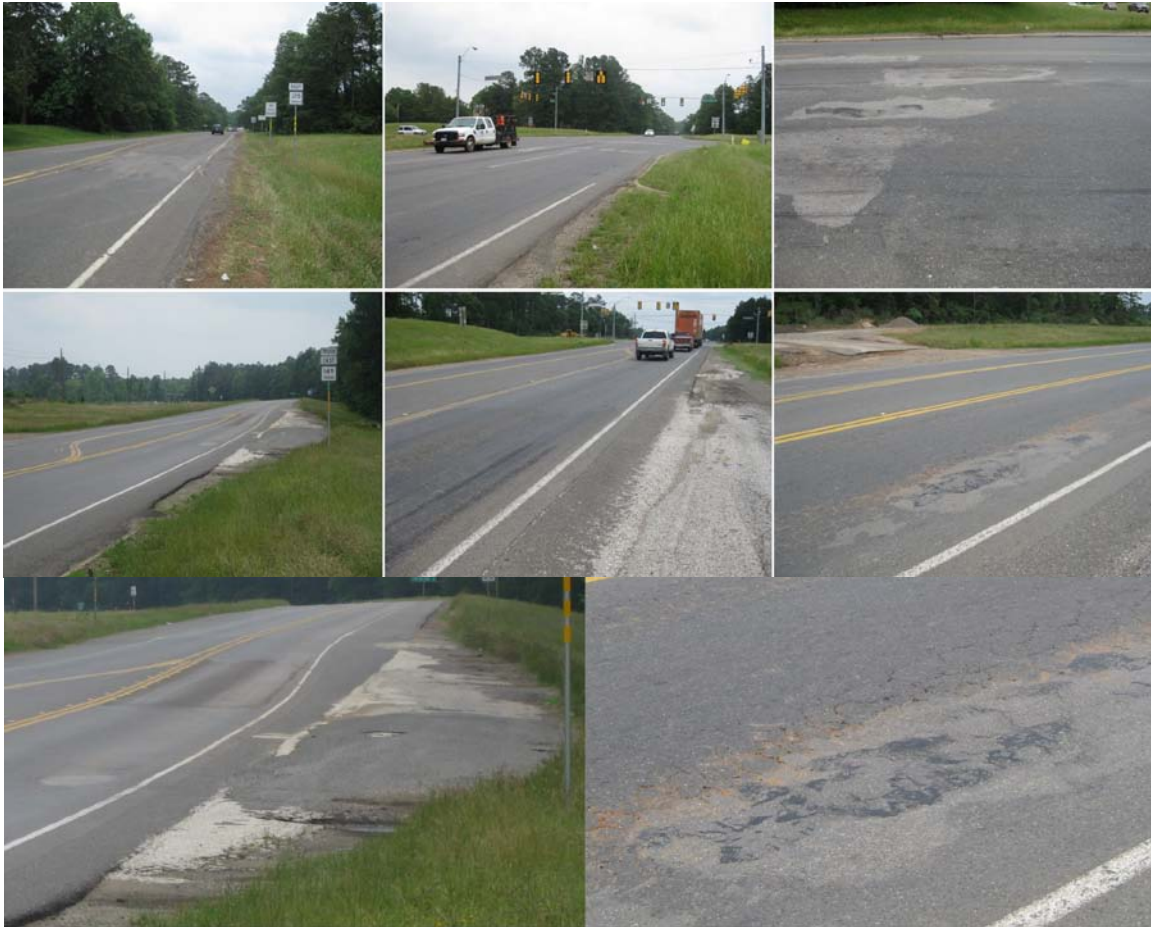
Figure 7.2 - Views of the Conditions of SH 315 and SH 149 Intersection.

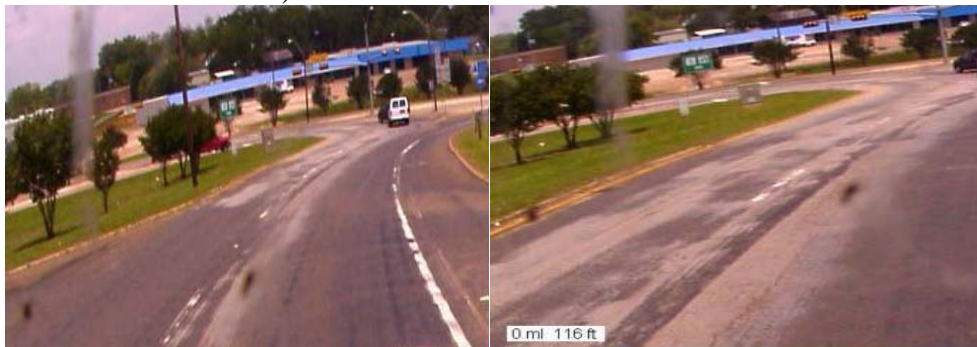
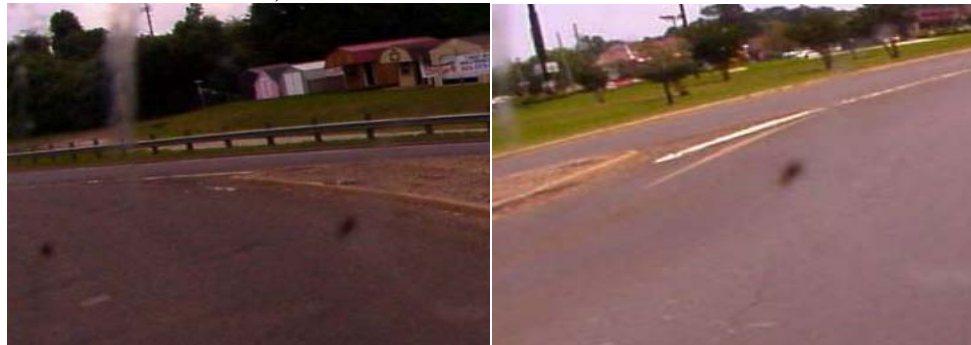
Figure 7.4 - Views of Conditions of US 259 and SH 11 Intersection.

With the assistance from District personnel, 500 ft sections of the road on either side of the intersections were closed off to traffic. Figure 7.4 shows different visible distresses. The primary distress observed at US 259 intersection northbound left lane approach was severe block cracking, at right lane approach was low severity transverse cracking, and shoving at the intersection. Also structural rutting or surface rutting was observed on the eastbound right lane and low severity transverse cracking along all four lanes. There was evidence of grinding on the southbound direction of the intersection. Deflection data confirmed that the rutting was in the surface layer. Likewise, some shoving and little rutting on the northbound left lane after the intersection were also found.

b) US 259 Northbound Outer Lane

c) SH 11 Southbound Inner Lane (left) and Outer Lane(right)

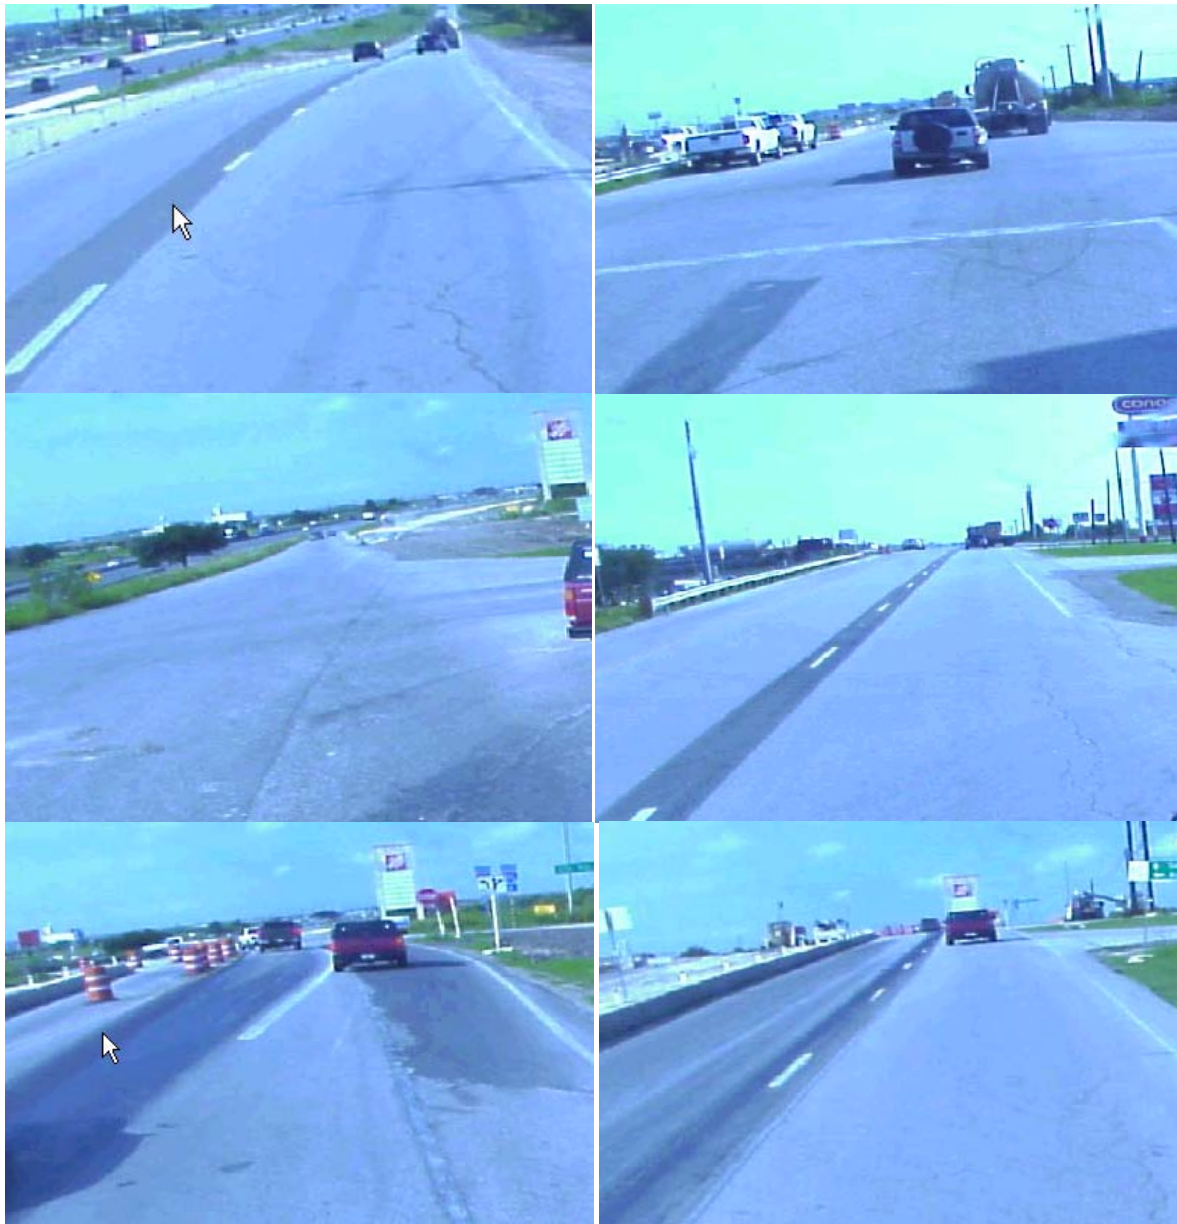
Figure 7.5 - Conditions on IH 35 and CR 210 Intersection.

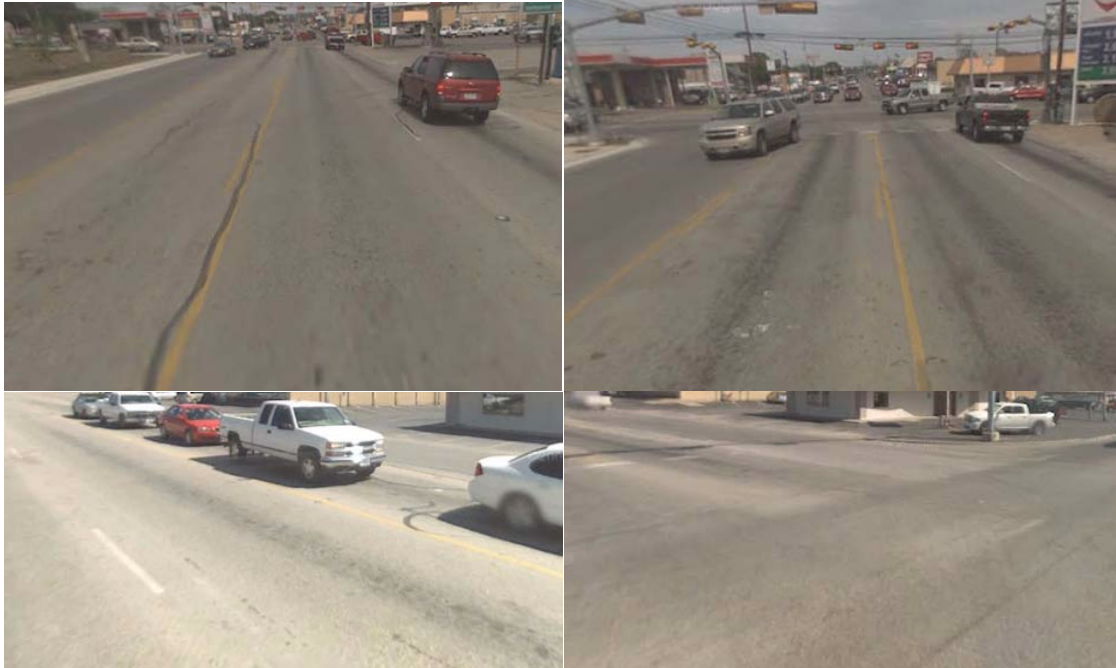
Figure 7.6 - Conditions of US 281 and SH 29 Intersection.

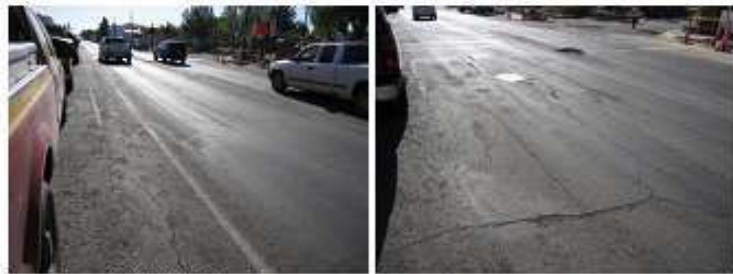
Location (A): US90 E. is one way street

- There are no stop signs, therefore no stop and go. However, major distress observed is rutting on the wheel path (structural rutting). Also, longitudinal cracking outside wheel path.

Figure 7.7 shows the severity of distress on US 90 East and 5th Ave. The intersection exhibited severe distresses ranging from rutting, alligator cracking, raveling, longitudinal cracking, and potholes. The major distresses on this roadway were in the upper layer and the predominant distress was alligator cracking. Since the site was under reconstruction a trench was available for investigating structural distresses. No structural rutting was observed in the lower layers.

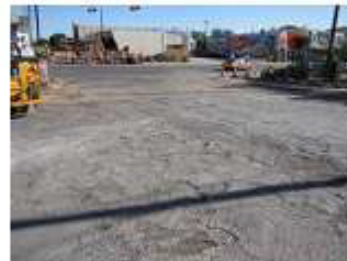
Location (B): US 90 East & 5th Ave Intersection

- Severe rutting and raveling. Also, alligator and transverse cracking.

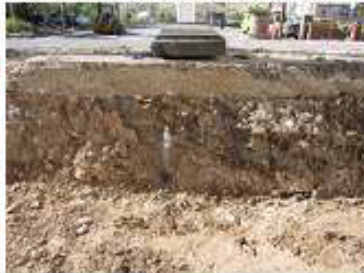
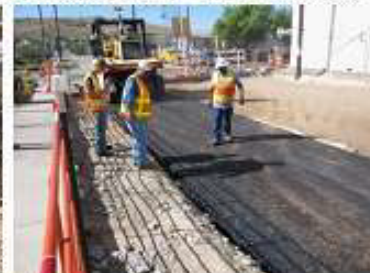
Figure 7.7 - Views of Conditions of Intersection at US 90 East & 5th Ave in El Paso District.

Location (D): 5th street south of intersection

- Stop sign, section under construction. Trench profile indicates structural rutting. Section will be rehabbed with ATB.

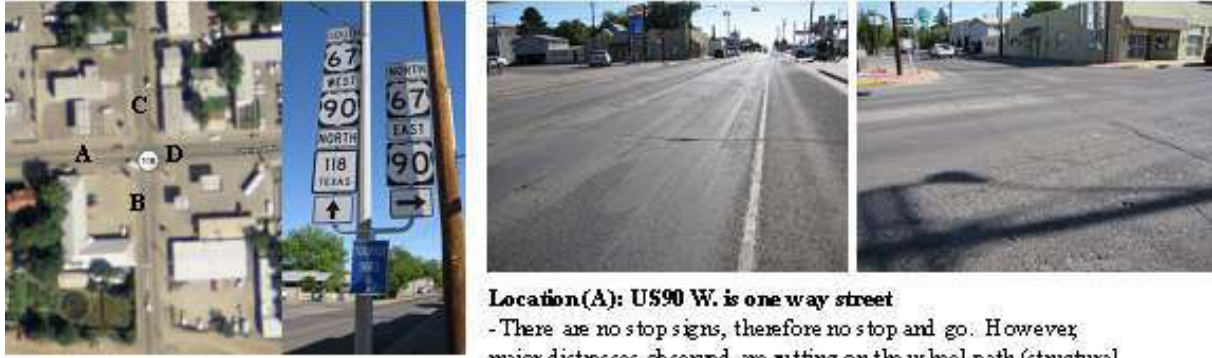
Figure7.8 - Views of Conditions of Intersection at US 90 East & SH 118 in El Paso District.

Intersection of US 90 East & SH 118

Location(A): US90 W. is one way street
 - There are no stop signs, therefore no stop and go. However, major distresses observed are rutting on the wheel path (structural rutting), alligator cracking, raveling and transverse cracking.

Location(D): US 90 East past intersection
 - Similar distress as at intersection.
 Drainage on both sides of roadway.

Figures 7.8 and 7.9 provide visual assessment of the conditions of the other two intersections. The US 90 East and SH 118 intersection similar to the intersection on 5th Ave exhibited severe levels of distress. However, since this intersection had four-way stop signs, shoving was the predominant distress. The US 90 West & 6th Ave intersection, similar to the 5th Ave intersection, the predominant distress was severe alligator cracking.

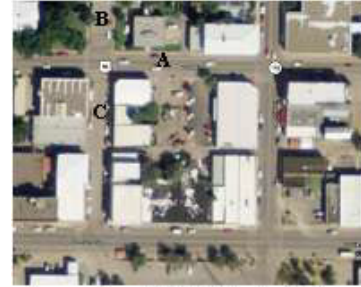
Figure7.8 - Views of Conditions of Intersection at US 90 West & 6th Ave in El Paso District.

Intersection of US 90 West & 6th Ave

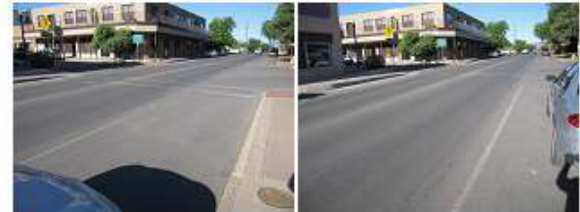
Location(A): US90 W. is one way street
 - There are no stop signs, therefore no stop and go. However, major distress observed is rutting on the wheel path (structural rutting). Also, longitudinal cracking outside wheel path.

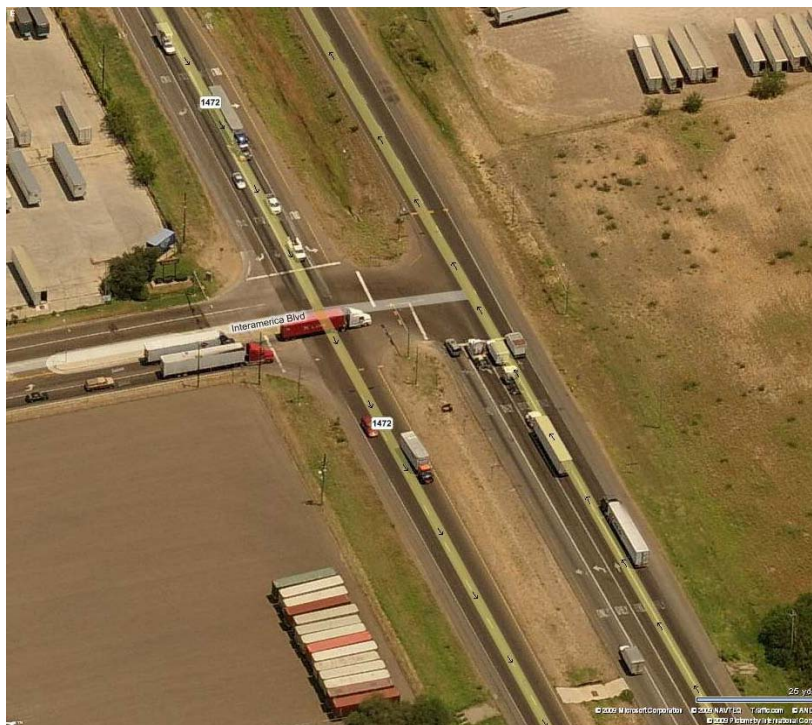
Figure 7.10 – Aerial Layout of FM 1472 and InterAmerica Blvd. Intersection.

Figure 7.10 depicts the aerial view of the intersection. A site inspection of the pavement was performed by TXDOT personnel. FM 1472 is a 2 lane road that is loaded with heavy truck traffic from the surrounding warehouses. InterAmerica Blvd. runs through the warehouse district ends at the intersection with FM 1472. The “T” shape intersection between these two roads is predicted to have a large amount of traffic with a very high truck ratio. On the 400 ft intersection approach two left turning lanes on both directions were added making FM 1472 an 8 lane road, while InterAmerica Blvd. become a 4 lane road 500 ft before reaching the intersection.

Severe Instability Rutting was by far the most predominant distress on FM 1472 as approaching the intersection. According to the District personnel rutting seems to be the same amount throughout the southbound section, while in northbound the rutting increases as getting closer to the intersection. Alligator cracking was also visible along the wheelpaths, but not a significantly as the rutting. Figure 7.10 shows different views of the intersections along FM 1472. On the southbound direction, the outer left turn lane was the most affected with approximately 1 in. rut depth 70 ft north from the intersection, and 1.5 in. depth 300 ft north of the intersection. In the northbound, rutting started to appear 225 ft before reaching intersection and increased in depth to 3 in. at the stop sign. The rutting in both directions presented humps on the sides, which are the signs of instability rutting of high severity.

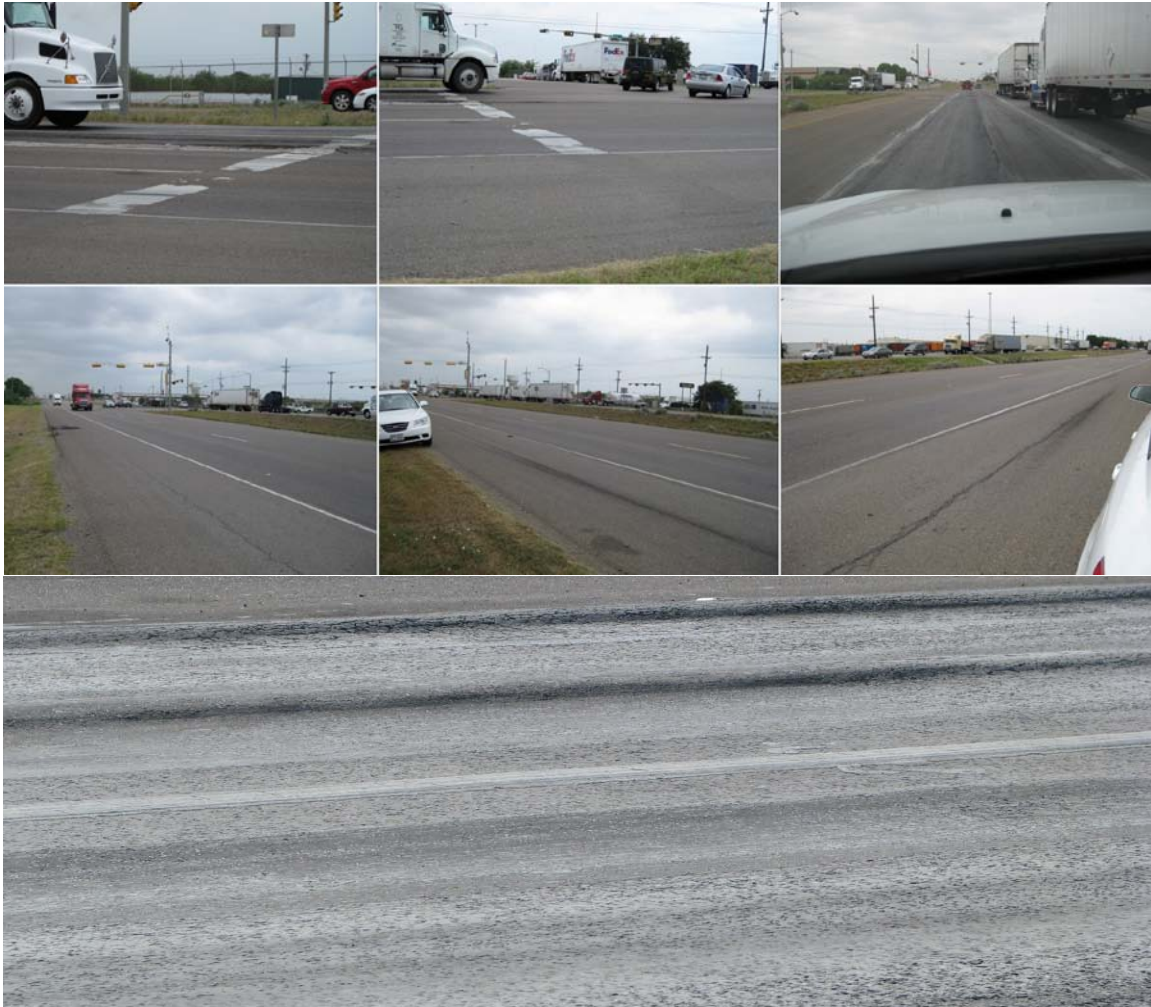
Figure 7.11 - Views of Conditions of Intersection at FM 1472 in Laredo District.

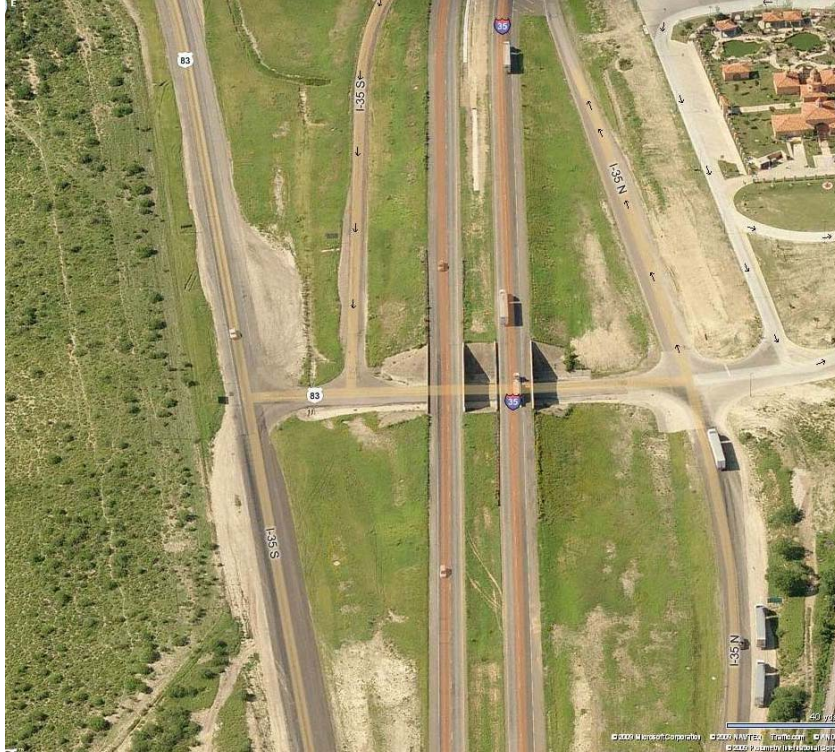
Figure 7.12 – Layout of US 83 and I-35 Intersection.

As shown in Figure 7.12, these roads intersect through a two-way approximately 400 ft long underpass that connects IH 35 off and on ramps with US 83. The most damaged section of the intersection was where the US 83 becomes I-35 southbound frontage road. The east end of the underpass I-35 intersection had been constructed with a PCC pavement. Apparently the underpass has a good drainage system running on the sides.

Multiple distresses were identified on the underpass, but the primary distress was severe alligator cracking specially on the inside lane. Other distresses were flushing, block cracking, longitudinal cracking and rutting. The type of rutting identified was surface rutting. Figure 7.14 shows the severity of the alligator cracking and rutting along the underpass. The rut depths were not measured because of the low severity.

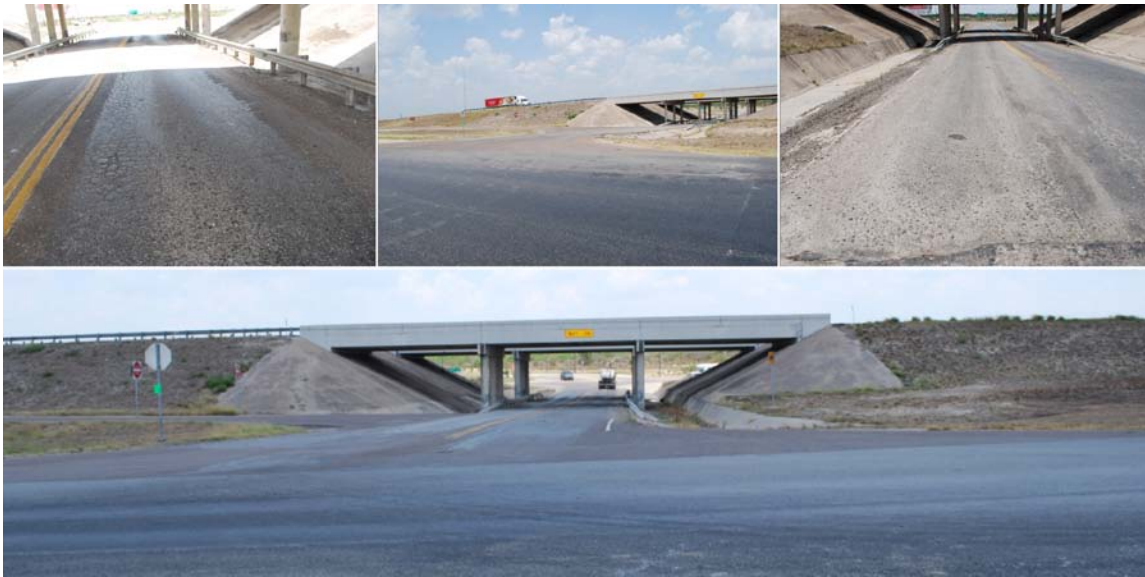
Figure 7.13 – Views of Conditions of US 83 and I-35 Intersection.

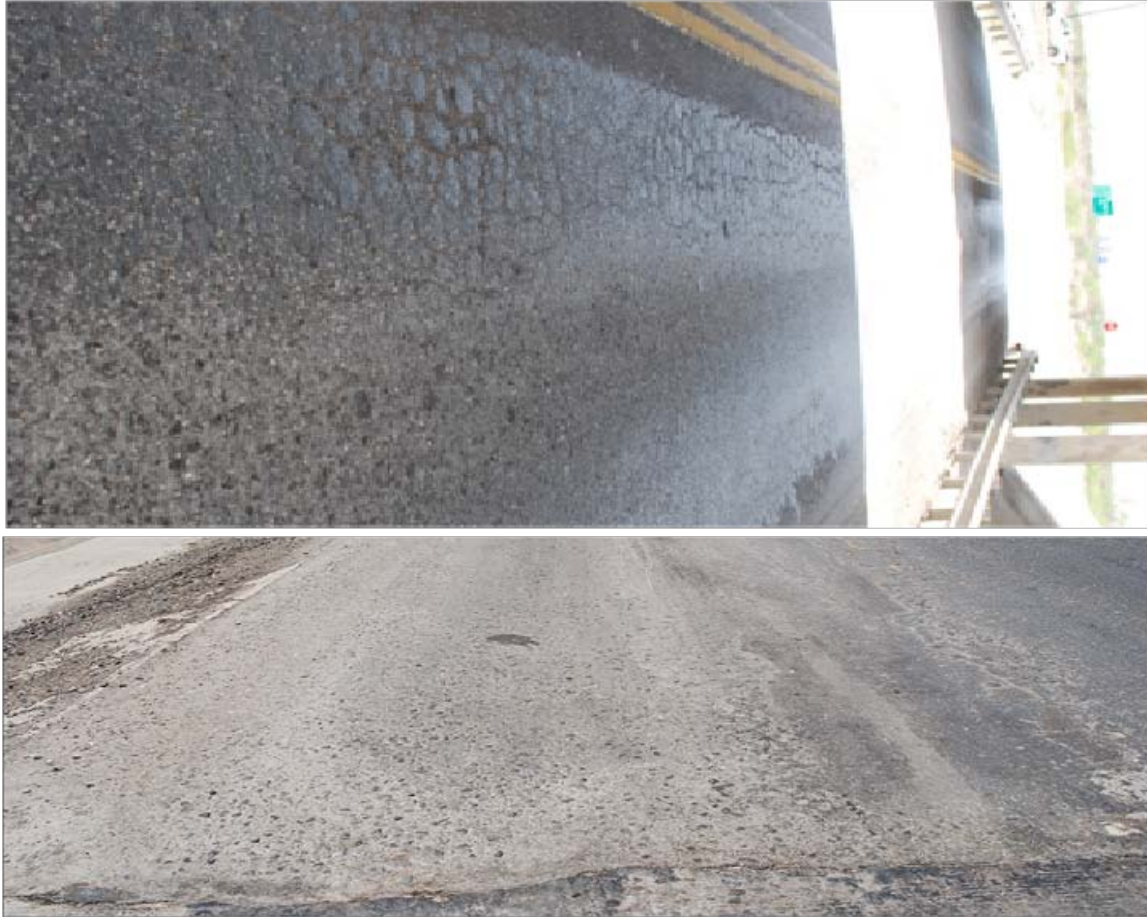
Figure 7.14 – Alligator cracking and Surface Rutting along US 83 Underpass.
