Strategies to Improve and Preserve Flexible Pavement at Intersections

Research Report 0-5566-1

Conducted for
Texas Department of Transportation
P.O. Box 5080
Austin, Texas 78763

January 2011

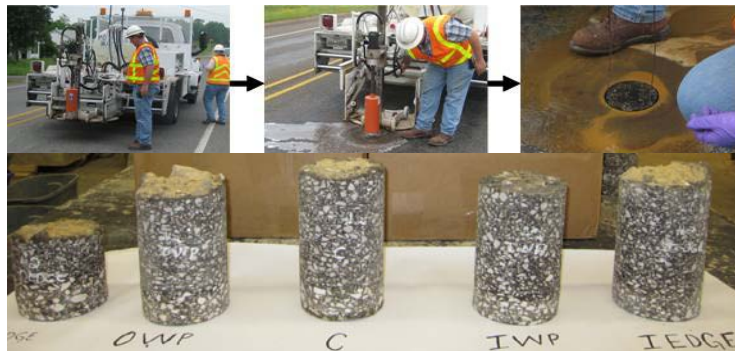
Figure 8.3 - Coring operation for a Core Profile across a Pavement Section.

Trenching and coring although destructive provide absolute verification of the structure of the pavement. Both methods require traffic control and patching once complete. Trenching operation provides viable information especially when structural rutting is suspect. Figure 8.2 is taken from the TxDOT Pavement Design Manual for illustration purposes. Since many District staff do not favor trenching especially at intersections, coring can be used as an alternative. Based on our experience, collecting five cores across the lane is quite valuable. The recommended locations of the cores are: inner edge, inside wheel path, center, outside wheel path, and outer edge. Figure 8.3 depicts a set of cores that were collected from one of the sites investigated under the project. The cores show the variation in thickness from the center core to the cores taken along the wheelpaths. 4-inch diameter cores are sufficient to identify any potential structural distress. It is recommended that a set of five cores be taken close to the intersection and another set away from the intersection. The two sets of cores can be used to determine whether the distress is localized at the intersection or is extended further in the roadway.

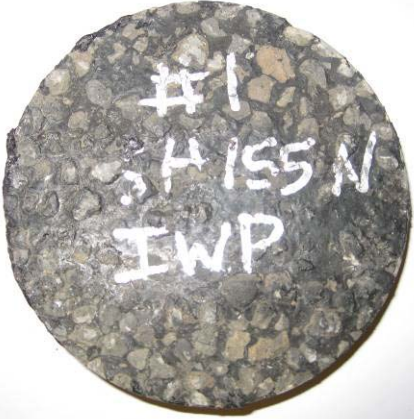
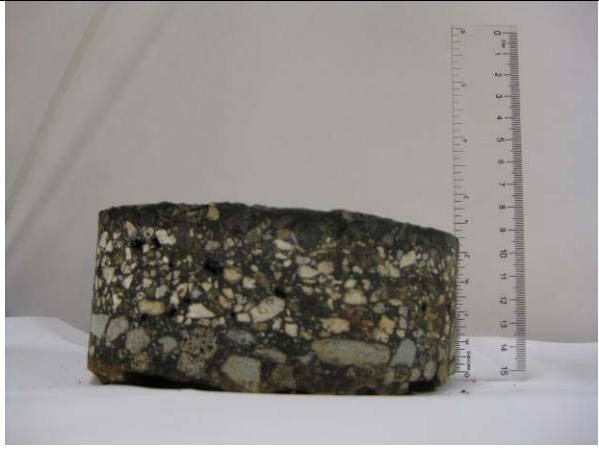
Table G2 - Core #1 Information for Inner Wheel Path on SH 155 South Bound

Intersection	District	Extraction Date																
SH 49 & SH 155	Atlanta	April 20, 2009																
Core	# 1 IWP

Thickness, in	1.9																	
Location	SH 155 South bound 500ft north																	
Modulus	319 ksi																	
Asphalt Content	8.57 %																	
Notes																		
Gradation:

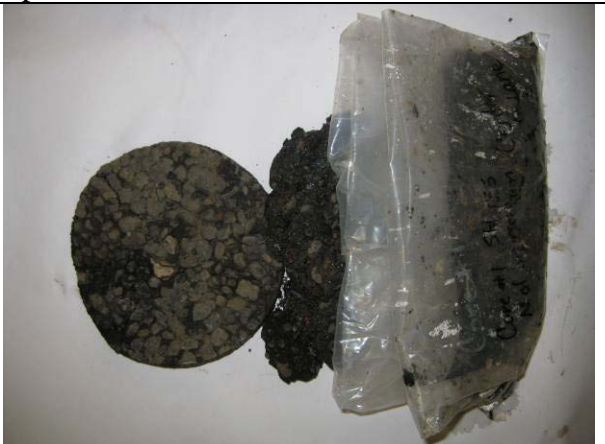
Table G3 - Core #1 Information for Center on SH 155 South Bound

Intersection	District	Extraction Date
SH 49 & SH 155	Atlanta	April 20, 2009
Core	# 1 Center

Thickness, in	.5	
Location	SH 155 South bound 500 ft north	
Modulus	215 ksi	
Asphalt Content	7.92 %	
Notes:		
Specimen broke apart while extracting, only 0.5 in thick slurry seal remained intact.		
Gradation:		
Size	(g)	
1/2"	2.6	
3/8"	135.8	
#4	563.5	
#40	438.6	
#100	158.2	
#200	36.2	
Pan(-200)	32.1

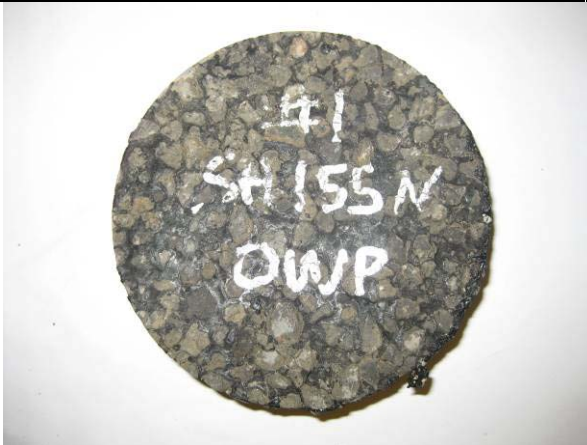
Thickness, in	2.5																
Location	SH 155 South bound 500 ft north																
Modulus	256 ksi																
Asphalt Content	6.99 %																
Notes: <ul style="list-style-type: none"> • Pieces of the specimen were lost during extraction • Low to severe fatigue cracking , rutting, loss of aggregate, bleeding, pushing, and block cracking • FWD data collected at this location

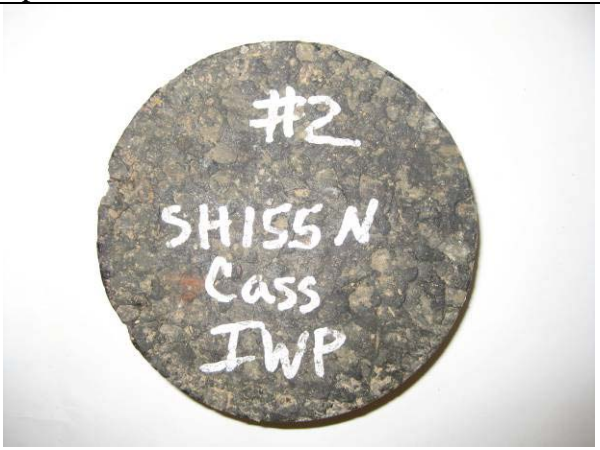
Thickness, in	2.2																	
Location	SH 155 South bound 100 ft north																	
Modulus	556 ksi																	
Asphalt Content	7.6 %																	
Notes: <ul style="list-style-type: none"> • Low to severe fatigue cracking , rutting, loss of aggregate, bleeding, pushing, and block cracking • FWD data collected at this location 																		
Gradation

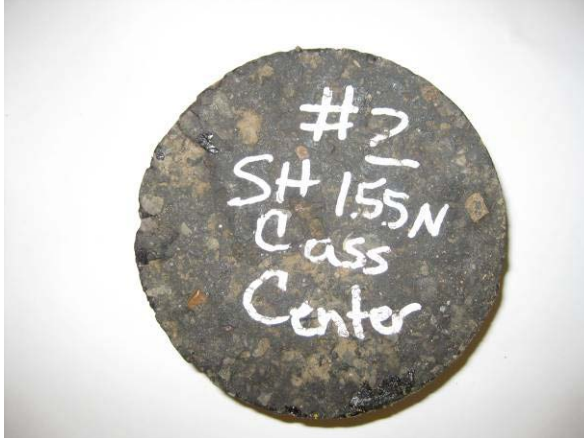
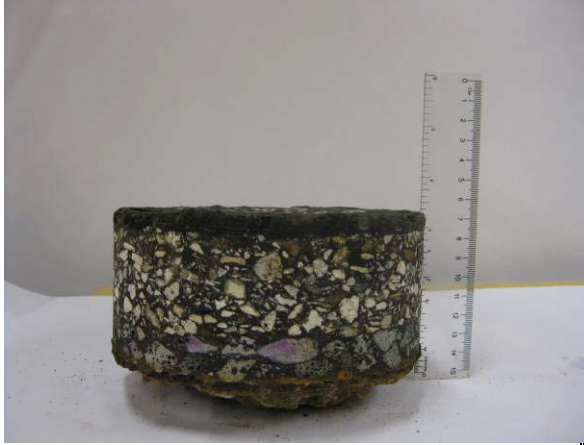
Table G6 - Core #2 Information for Center on SH 155 South Bound

Intersection	District	Extraction Date																
SH 49 & SH 155	Atlanta	April 20, 2009																
Core	# 2 Center

Thickness, in	2.5																	
Location	SH 155 South bound 100 ft north																	
Modulus	547 ksi																	
Asphalt Content	8.46 %																	
Notes: Cement detected on the base with Phenolphthalein																		
Gradation

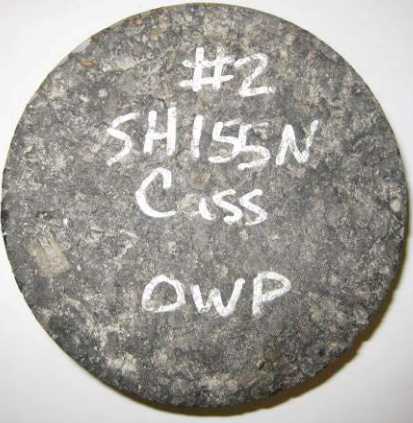
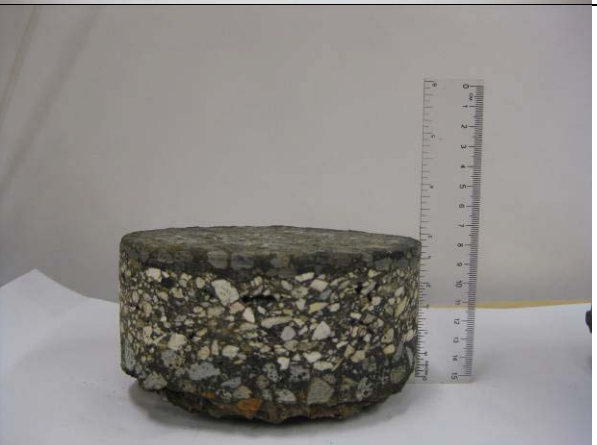
Table G7 - Core #2 Information for Outer Wheel Path on SH 155 South Bound

Intersection	District	Extraction Date
SH 49 & SH 155	Atlanta	April 20, 2009
Core	# 2 OWP

Thickness, in	2.4	
Location	SH 155 South bound 100 ft north	
Modulus	581 ksi	
Asphalt Content	7.78 %	
Notes:		
Gradation

Size	(g)	
1/2"	34.8	
3/8"	133.8	
#4	359.8	
#40	425.7	
#100	247.2	
#200	108.8	
Pan(-200)	17.8

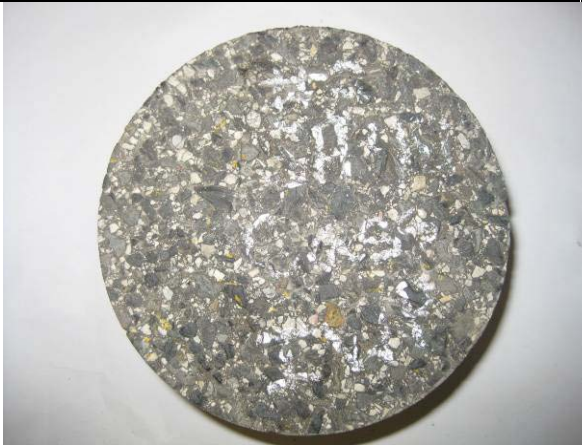
Thickness, in	4.2	
Location	SH 49 Eastbound 500 ft West	
Modulus	671 ksi	
Asphalt Content	4.83 %	
Notes: <ul style="list-style-type: none"> • Cement detected on the base with Phenolphthalein • 42 yards milled by maintenance, severe block cracking and rutting • T cracking all the way • 10 in treated base 		
Gradation		
Size	(gr)

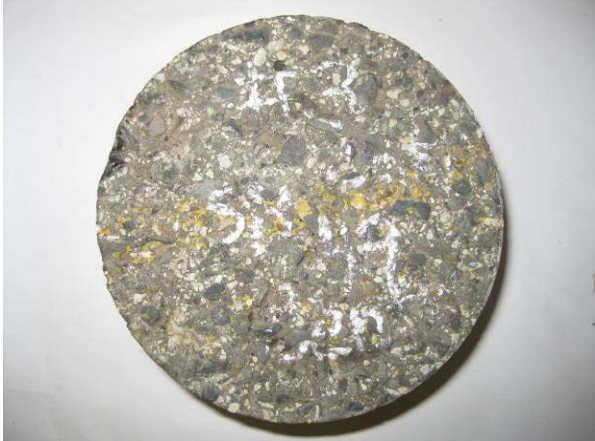
Thickness, in	4.2	
Location	SH 49 Eastbound 500 ft West	
Modulus	562 ksi	
Asphalt Content	4.93 %	
Notes:		
<ul style="list-style-type: none"> • Cement detected on the base with Phenolphthalein • 42 yards milled by maintenance, severe block cracking and rutting • T cracking all the way • 10 in treated base 		
Gradation		
Size	(g)

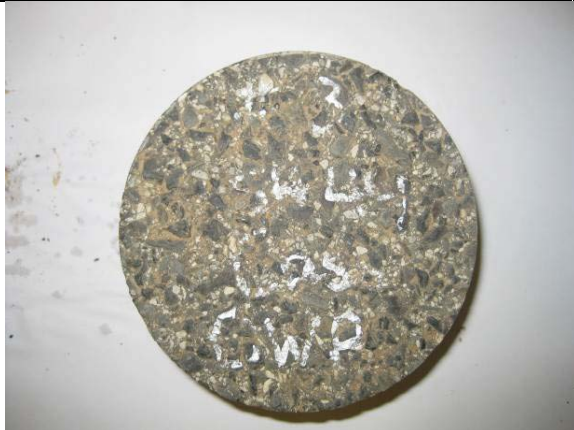
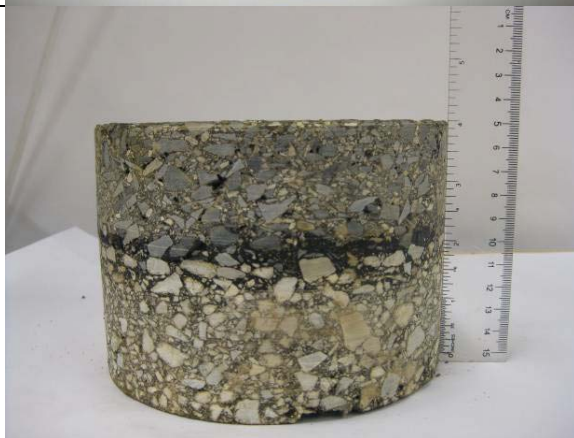
Table G10 - Core #3 Information for Outer Wheel Path on SH 49 East Bound

Intersection	District	Extraction Date
SH 49 & SH 155	Atlanta	April 20, 2009
Core	# 3 OWP

Thickness, in	4	
Location	SH 49 Eastbound 500 ft West	
Modulus	590 ksi	
Asphalt Content	5.4 %	
Notes:		
Cement detected on the base with Phenolphthalein		
Gradation

Size	(g)	
1/2"	28.8	
3/8"	122.5	
#4	437.8	
#40	695.6	
#100	100.8	
#200	9.8	
Pan(-200)	12.8

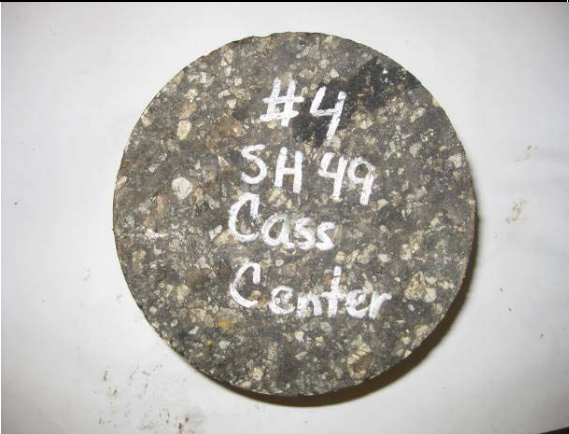
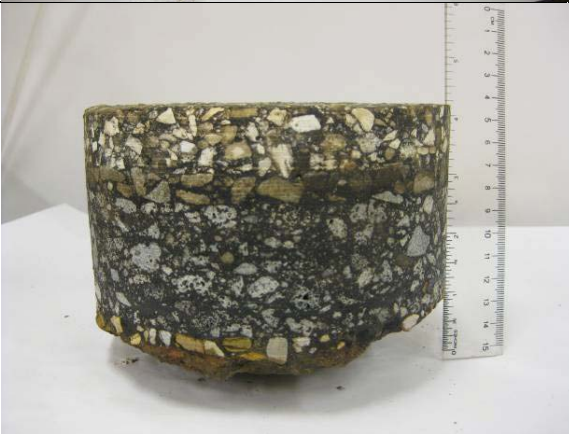
Table G12 - Core #4 Information for Center on SH 49 East Bound

Intersection	District	Extraction Date
SH 49 & SH 155	Atlanta	April 20, 2009
Core	# 4 Center

Thickness, in	3.1	
Location	SH 49 Eastbound 75 ft West	
Modulus	600 ksi	
Asphalt Content	6.89 %	
Notes:

Gradation		
Size	(g)	
1/2"	95.4	
3/8"	195.8	
#4	326.1	
#40	377.6	
#100	203.7	
#200	109.8	
Pan(-200)	75

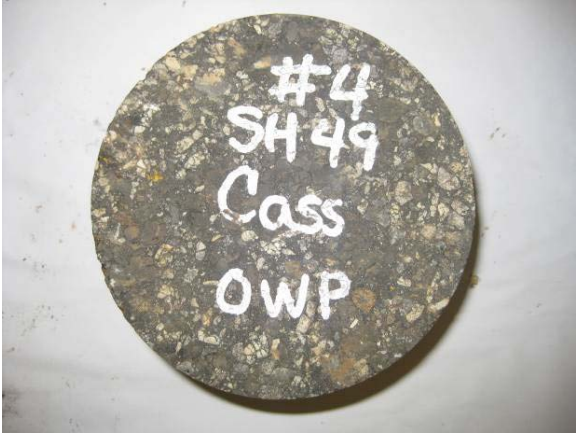
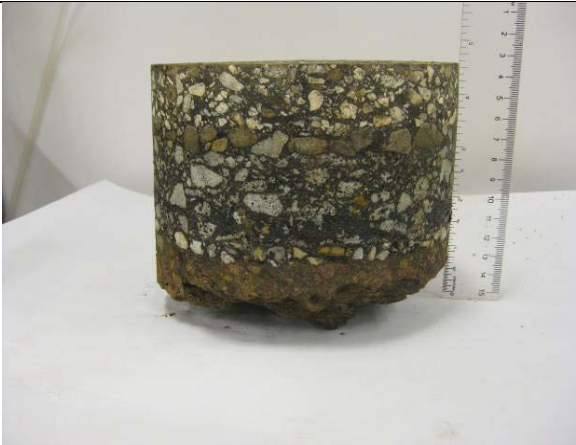
Table G13 - Core #4 Information for Outer Wheel Path on SH 49 East Bound

Intersection	District	Extraction Date
SH 49 & SH 155	Atlanta	April 20, 2009
Core	# 4 OWP

Thickness, in	3.1	
Location	SH 49 Eastbound 75 ft West	
Modulus	571 ksi	
Asphalt Content	6.58 %	
Notes:		
Gradation		
Size	(g)

1/2"	89.6	
3/8"	181.6	
#4	327.9	
#40	394.8	
#100	265.5	
#200	100.3	
Pan(-200)	12.8
